2024 Toyota Sienna LE AWD

VIN: 5TDKSKFC0RS138843
Mileage: 96,380
Engine: 2.5L four-cylinder hybrid
Transmission: Electronic continuously variable automatic
Asking price: $34,999

VEHICLE INSPECTION REPORT

REPORT NUMBER
VIH-00063

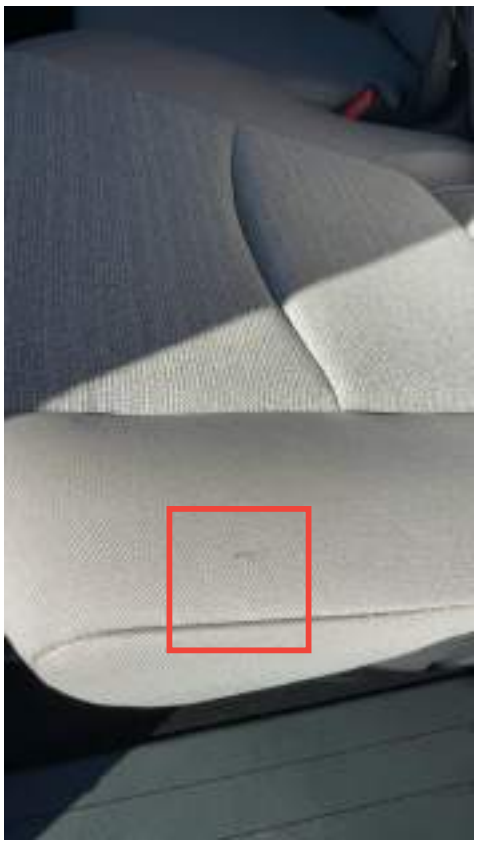
Seats

Found light staining.

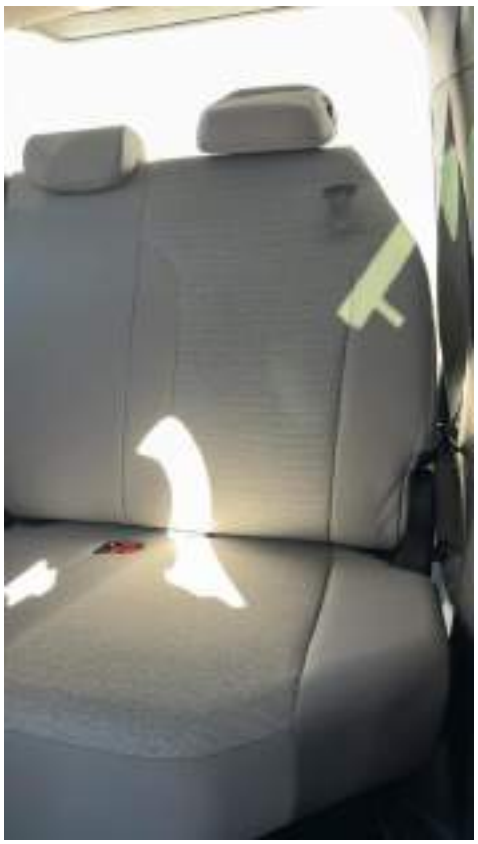
Seats

Found light staining.

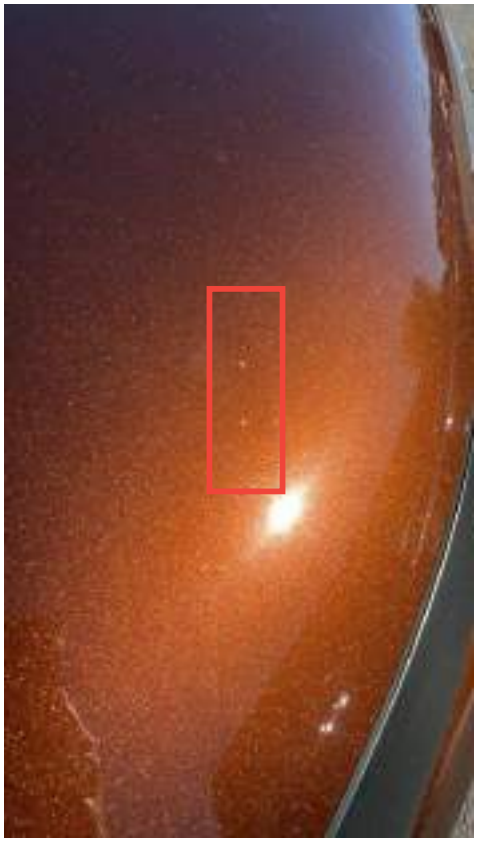
Front Bumper

Undeniable there's blemishes, but also looks like a lot of…
